Seafloor Swathe Survey for Search and Rescue Mission of Air Asia QZ8501

POERBANDONO Indonesia

SUMMARY

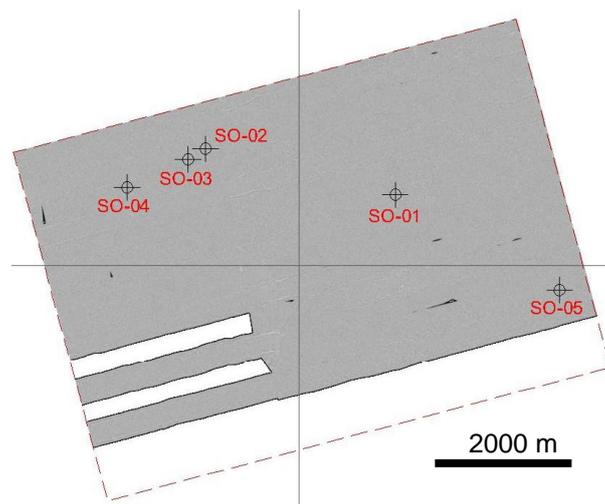
Figure 4 SSS mosaic with markers of Suspected Object (SO) in Area-2

As detected by SSS, five sonar contacts were recorded here (Figure 4) and considered as suspected objects due to their size. Details of suspected objects recorded in Area-2 are listed in Table 2. From MBES point cloud data, however, only SO-04 is understood to indicate significant dimension, particularly its apparent height. No significant height is detected from the rest of suspected objects.

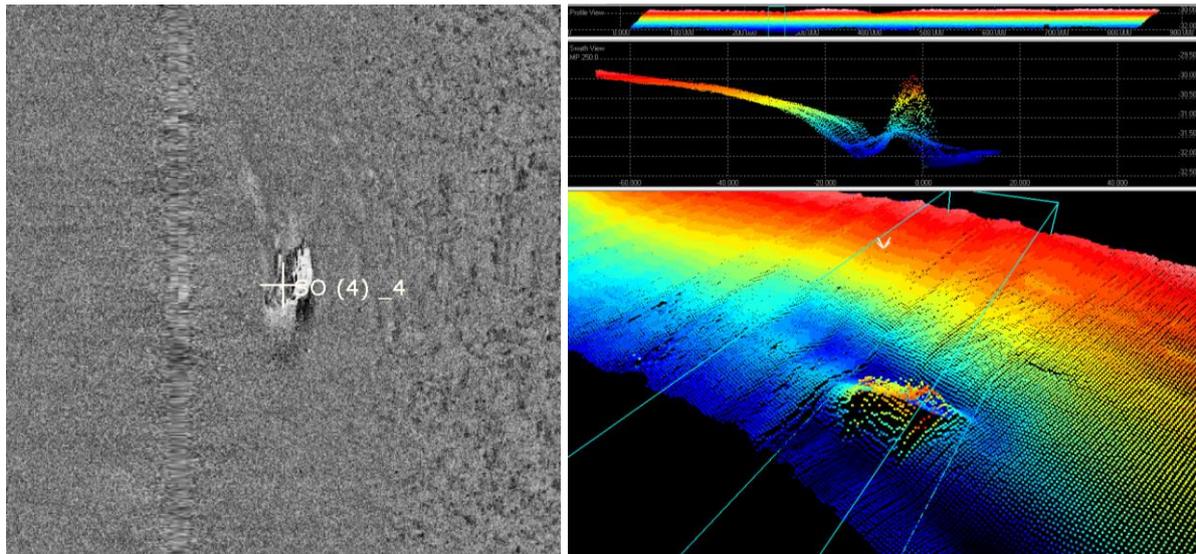
(a) SSS imagery (b) MBES point cloud
 Figure 5 Sonar records of suspected object in SO-04

ROV deployment assisted by USBL positioning system and diving operations by the Indonesian Navy diving team were conducted to identify SO-03 and SO-04. These visual and manual inspections lead to a conclusion that these two objects are not associated with any parts of the airplane. The deployment of ROV and diver to validate SO-03 (although it does not indicate significant apparent height) is carried out in order to provide control evidence. Sonar contacts in SO-04 are shown in Figure 5. Figure 6 shows ROV footage of SO-04 indicating an object thought as wreck covered by coral colony. Relatively deep water and strong current do not allow good visibility.

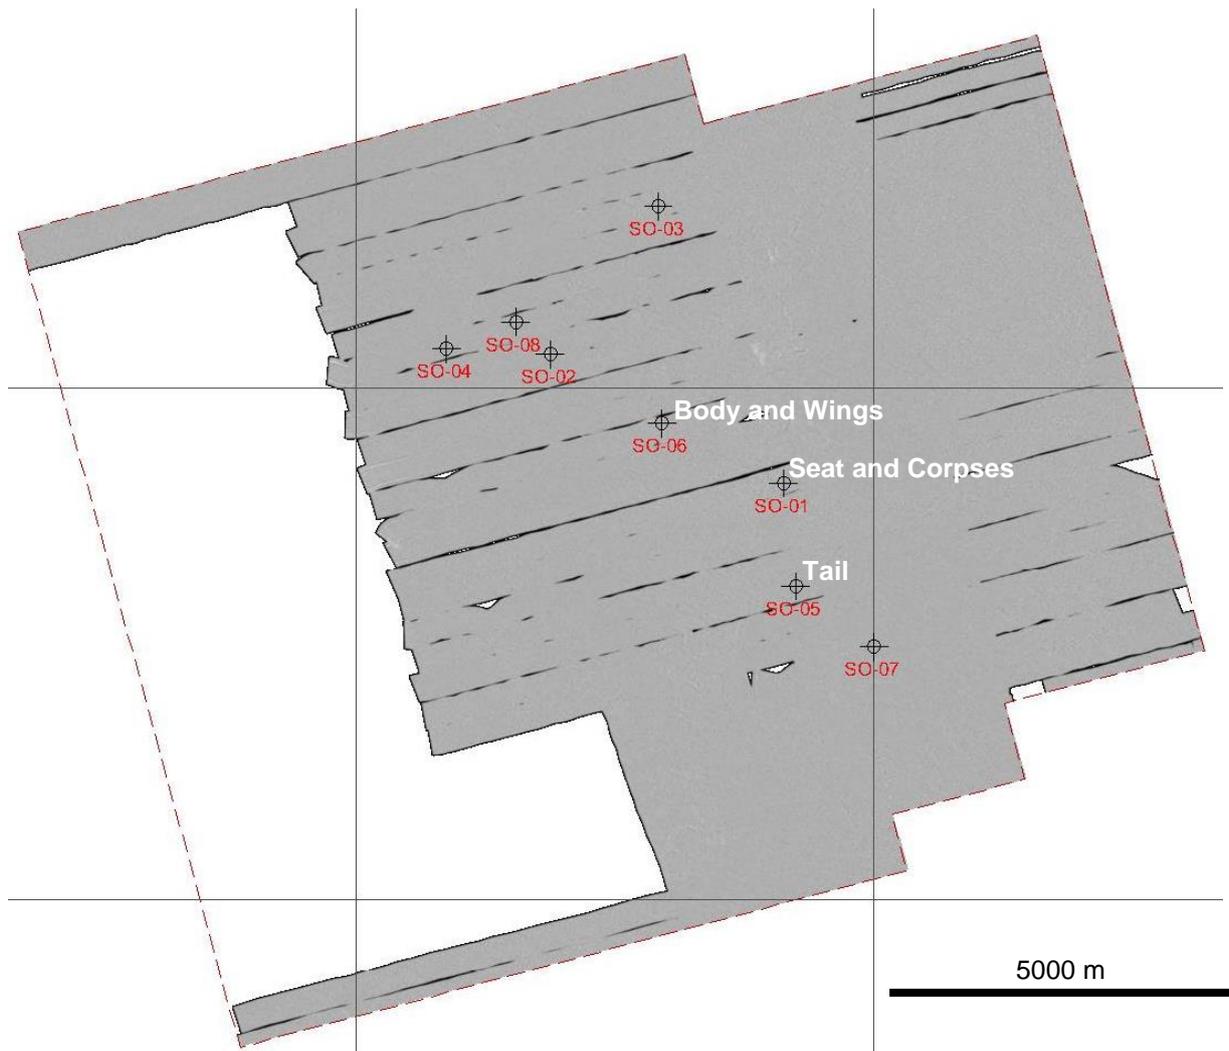
Figure 7 SSS mosaic with markers of Suspected Object (SO) in Area-3

Eight sonar contacts were recorded by SSS and their apparent heights were also measured by MBES, hence interpreted as suspected objects. ROV deployment assisted by USBL positioning system and diving operations were conducted to verify six of them. Figure 7 shows suspected objects in Area-3 as appear on SSS image mosaic. Table 3 shows list of the corresponding suspected objects. Verification through visual detection using ROV and manual inspection by divers confirmed that SO-01, SO-05, and SO-06 are parts of the missing airplane. In particular, SO-05 is identified as the tail. SO-01 is confirmed as seats and corpses. It is validated that SO-06 are the body and wings.

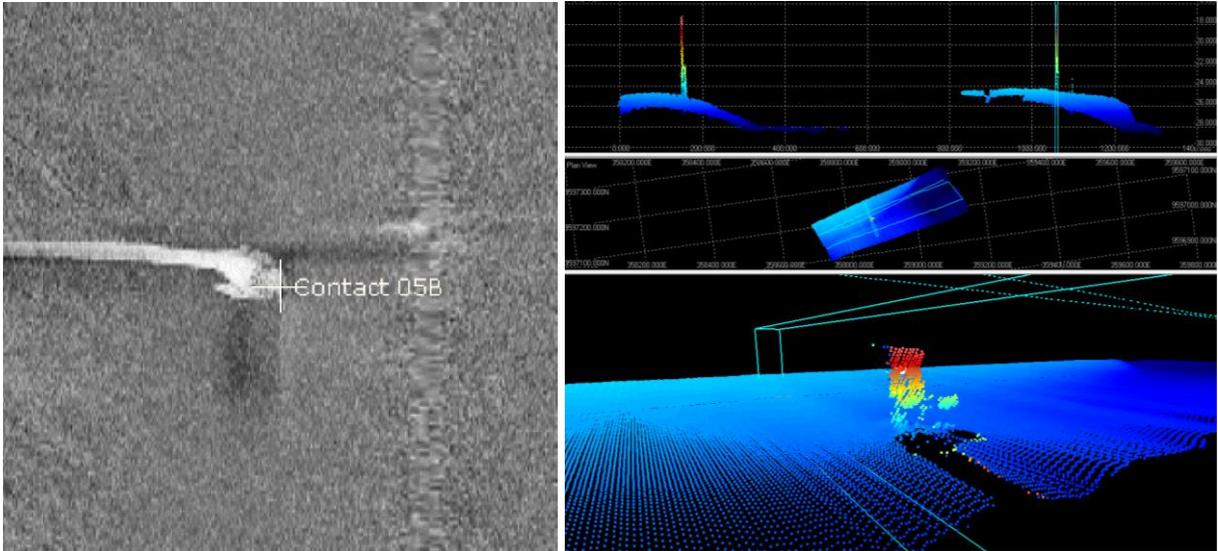
(a) SSS imagery (b) MBES point cloud
 Figure 8 Sonar records of suspected object in SO-05

Figure 8 shows SSS image and MBES point cloud data of SO-05. The corresponding ROV footage and underwater photograph taken by diver are shown in Figure 9. It is validated that the object is the tail of Air Asia QZ8501.

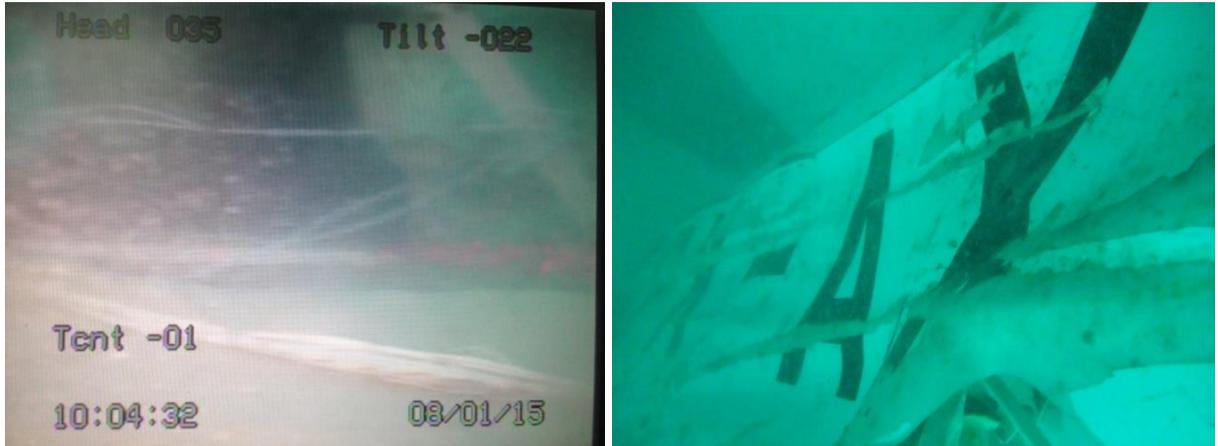
(a) ROV footage (b) Diver photograph
 Figure 9 Photos of suspected object in SO-05 identified as tail

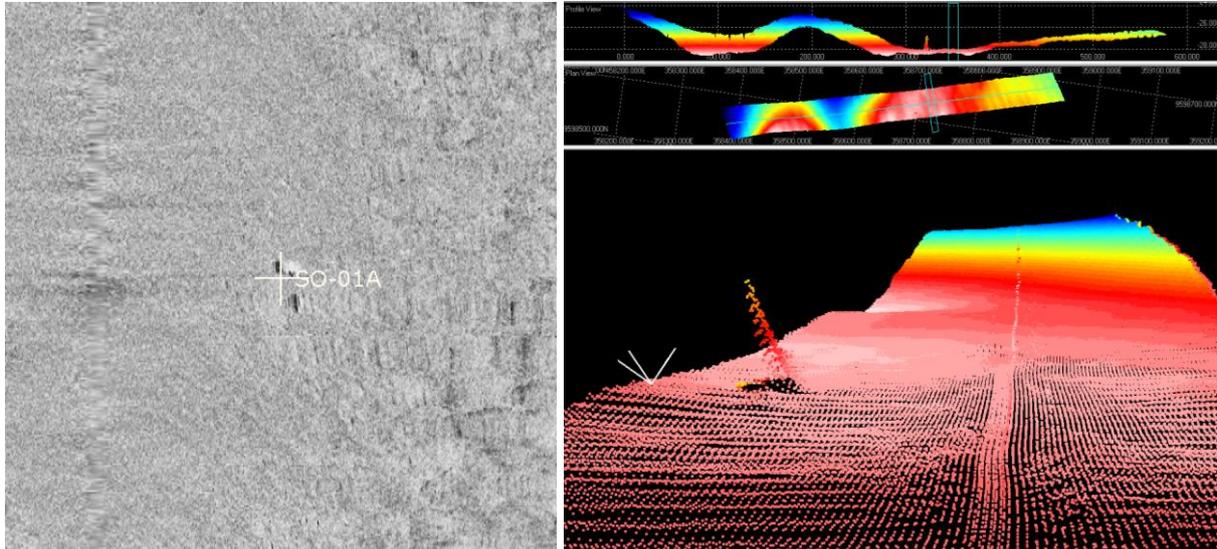
Figure 10 Sonar records of suspected object in SO-01

Figure 10 shows SSS image and MBES point cloud data of SO-01. It is identified that these objects are seat and corpses. AKSLI vessel was ordered to recover the object found in SO-01. Figure 11 shows the underwater photograph of object found in SO-01 and the evacuation of casualty on board of MGS GEOSURVEY vessel.

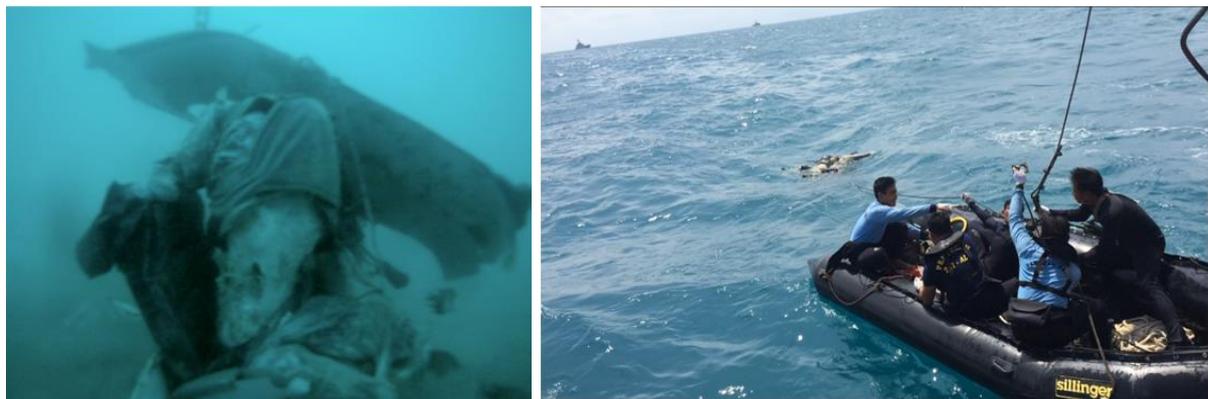
Figure 11 Recovery of seat and corpses found in SO-01

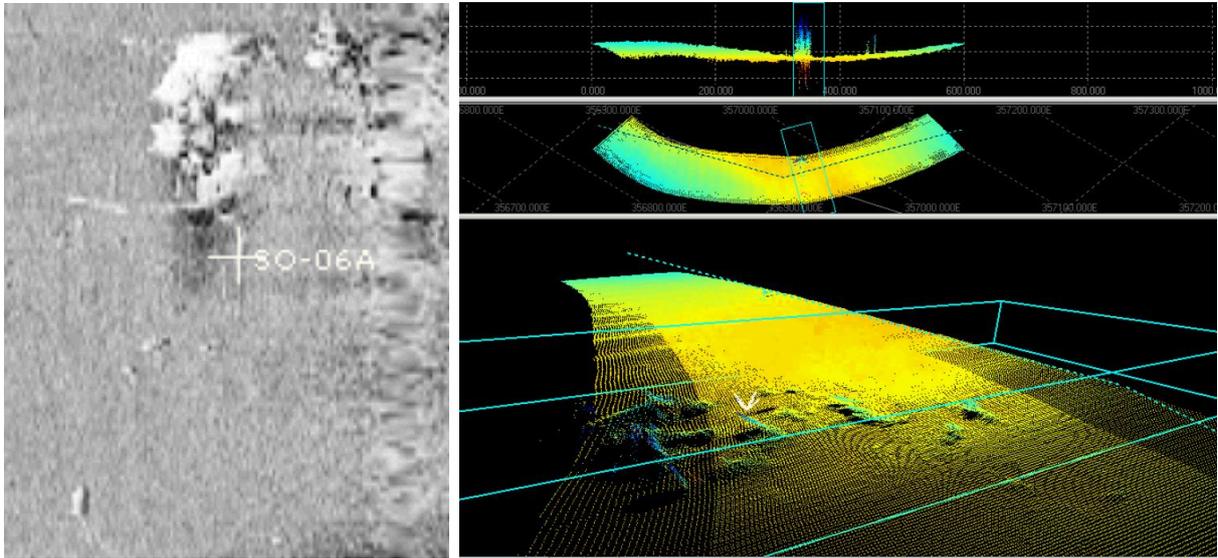
(a) SSS imagery (b) MBES point cloud
 Figure 12 Sonar records of suspected object in SO-06

Figure 12 shows SSS image and MBES point cloud data of SO-06. Validation of SO-06 is executed by ROV from MV Swift Rescue. It is confirmed that these are main body and wings of the plane. Figure 13 shows ROV footage of object identified as SO-06.

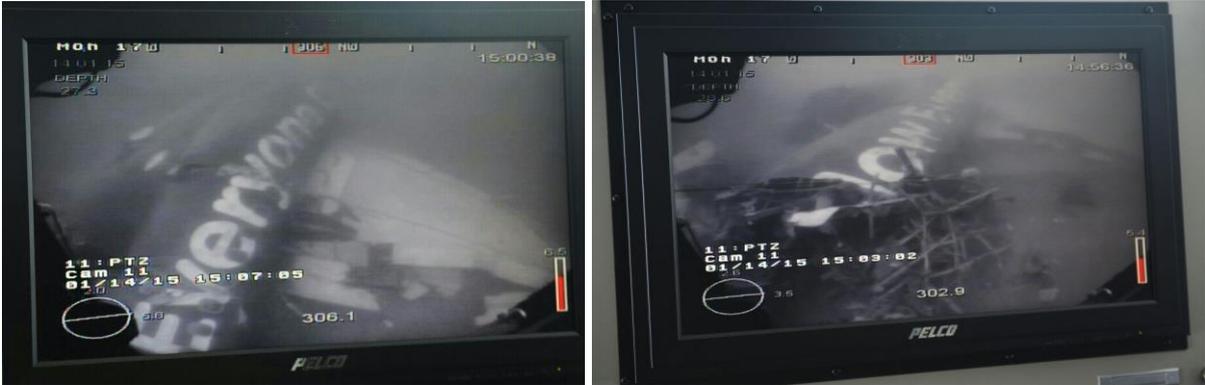
Figure 13 ROV footages of suspected object in SO-06 (Photo: MV Swift Rescue)

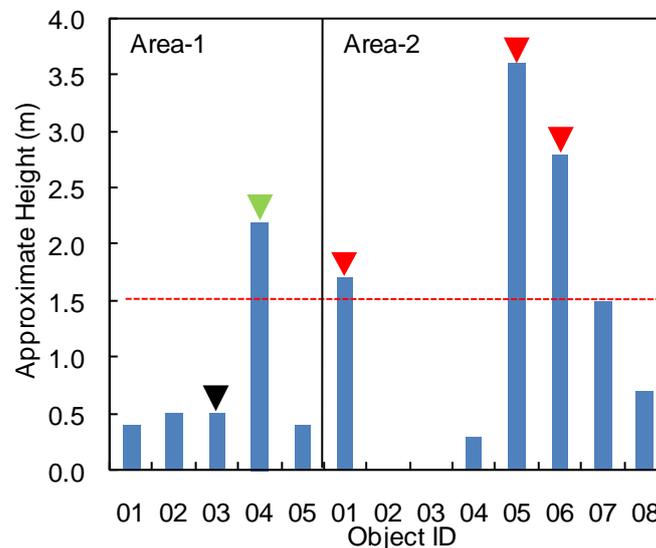
Figure 15 Summary of height of suspected object in Area-2 (01 to 05) and Area-3 (01 to 08)

In Figure 15, summary of detected heights of suspected objects from Area-2 and Area-3 is visualized. Looking at the recorded heights of suspected objects, it seems that anomalous heights of greater than 1.5 m may lead to an approximation of non-natural objects. Red triangles in Figure 15 indicate heights of objects measured by MBES that lead to presence of parts of the missing airplane, as validated by direct inspection.
