Advantages of deformation measurements for a deep excavation of an unstable slope in order to implement a hydropower development

Abstract. In order to implement the Livezeni Hydro Power Plant on the Jiu River, the construction of the dam required a diversion channel through the left bank. Constructing the diversion channel imposed a deep trench excavation and thus steep slope which often slid in time. In this regard, a bored and anchored column piles support was made, designed for the slope movement control. In this site there is also an important railway. The stringent conditions of displacement control could be ensured by adopting a comprehensive monitoring system using inclinometers. The inclinometer system had to provide both information about the displacement of the column wall and railway track, also revealing any potential crest and slope instability. With the finished columns, the excavations began under their shelter and as the excavation progressed also the two rows of anchorage were rigged-up. Measurements made during the carrying out of the excavation revealed, at a given moment, that the displacements were larger than designed due to the position of initially estimate

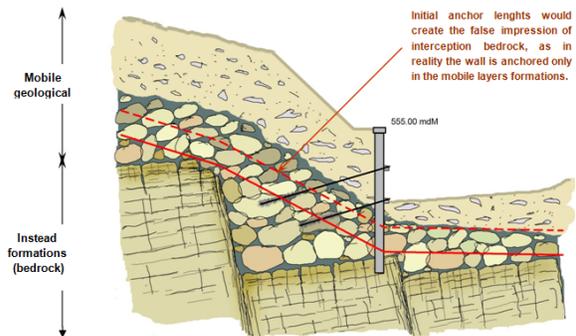
The implementation of the original anchors, at their designed length would create the false impression of intersecting the stabile bed-rock, where as in reality the wall was anchored only in the mobile layers formations.

Fig. 1 The anchor length in accordance with the original design did not correspond with the real geological configuration and could not have ensured the stability of the pile columns wall.

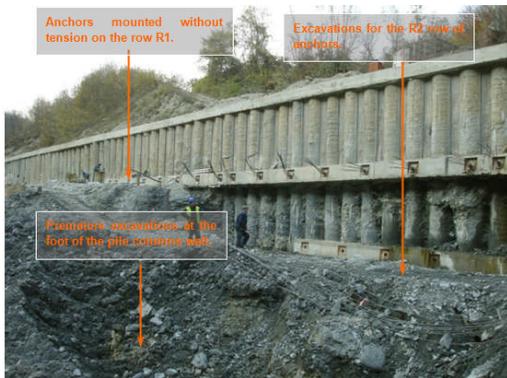
Fig. 2 The state of the works at the moment of taking over the project by TUCEB. Anchor installation

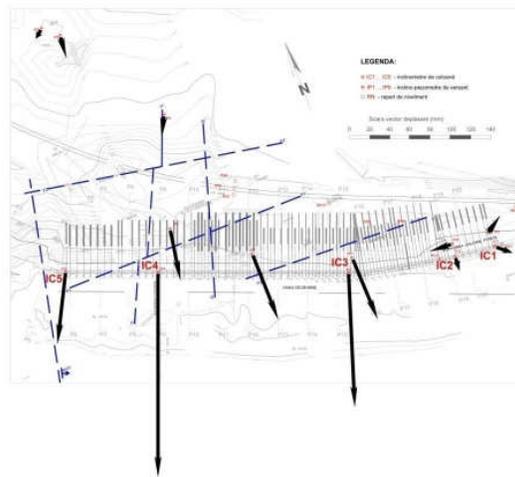
Fig. 3 Position of the pile column inclinometers IC1 - IC5

Figure 3 shows the position of the pile column inclinometers IC1 - IC5 and maximum

displacement vectors recorded, in the context of charted recorded displacements throughout the slope.

The highest displacement values were recorded at the IC3 inclinometer with 129 mm and IC4 inclinometer with 171 mm. These inclinometers were oriented perpendicular to the columns wall and their values were rather high, if we take into account that these are relative to a subsequent measurement at the first excavation stage of the downstream panels. These values are generally within the maximum acceptable interval for deformations of the pile columns, as defined by the emergency situations of the initial design, TP and DE phases. Outlined below are the results of IC4 inclinometer measurements.

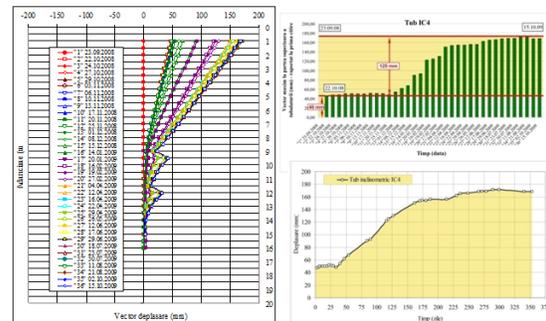
Fig. 4 The measurements results for IC4 pile column inclinometer, depth and displacement vectors. Evolution of the slope displacement vector magnitude recorded during the development works at IC4 inclinometer.

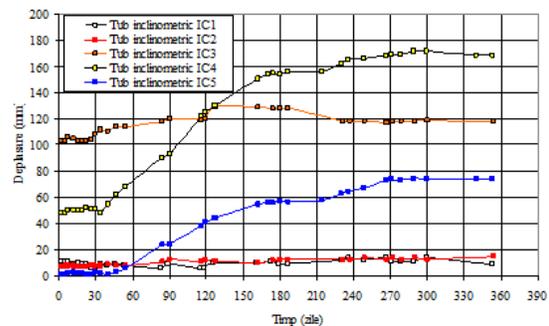
In Figure 5 there are represented, on the same graph, comparatively, the evolutions of displacements measured by IC1 - IC5 column inclinometers, scaled on the time during the works, in order to highlight the comparative evolution of the displacements growth rate and identify the effects of different events.

Fig.5 Comparative graph of the evolution for the displacements recorded by IC1 - IC5 pile column inclinometers during the works

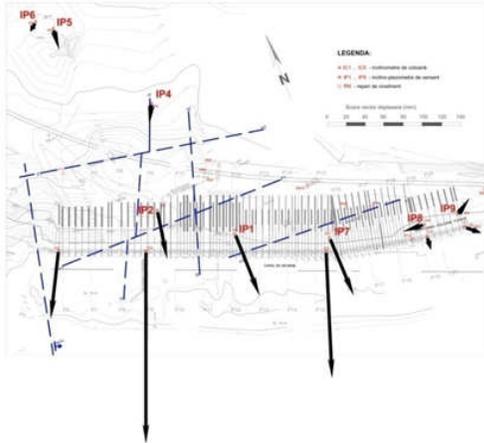
Fig. 6 The position of inclined piezometers IP1 - IP9 in the work location and the maximum recorded displacement vectors (1 m below ground level) in the context of recorded displacements throughout the slope.

- Displacements size gradually increases from the crest of the slope to the columns wall, correlated with the usual behavior of slopes subjected to deep toe excavations. The maximum displacements recorded throughout the works, corresponding to the depth of 1 m below ground level, gradually ranging between about 6 mm in IP6 and about 67 mm in IP1 and IP7. This distribution of displacements invalidates initial fears related to the triggering of local instabilities, independent from the deep toe excavation, which could affect the railway track.

- Orientation of the displacement vectors deviates from the direction of the excavation, being rotated and relatively perpendicular on the longitudinal fault lines, suggesting an overall displacement for the mobile covering layer formations, controlled by the bedrock line. These formations are not controlled by the largest slope line of the terrain as

expected. The exception comes at IP8 and IP9 tubes, located at the downstream end of the wall, where fillings prevails and where the excavation was not completed, at the toe of the wall. All other piezometers have confirmed these allegations.

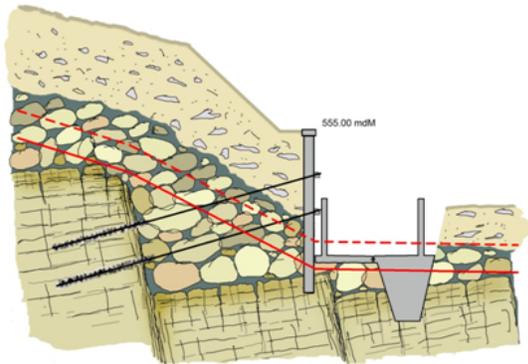
Fig. 7. Pile column wall with the anchors – holding the slope for the diversion channel in the actual on site conditions

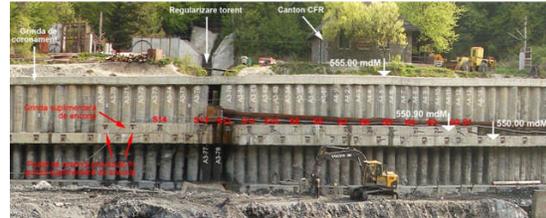
Fig. 8 The general disposition of the additional works, on the trained torrent zone and railway canton. (Additional anchor beam and additional anchors S1 ... S14.)

After analyzing the deformation measurements it was decided, according to the new image of the site geology, that an increase in length of the anchors should be adopted of 25 m in length and 15 m for the bulbs, maintaining virtually the same free length as in the initial design phase DE, so granting the same stiffness.

Also the geological configuration imposed the implementation of the same type of anchors for the entire columns wall, differently than the original draft, and thus the extra length for the anchors and length for the bulbs of the bottom row. In addition to the strengthening of the railway canton area as compensation of the tension deficit in the R1 row, an additional row (Rs) with 14 anchors was commissioned, pretensioned to the values that, in theory, would have been mobilized in the R1 row in the initial design. For the set-up of this additional row, a new beam anchor was constructed, positioned over the 550.00 m ASL beam and additional fillings had to be done in order to ensure access to this elevation.

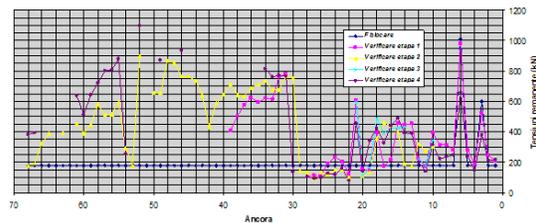
The verification of the residual tensions in the first 40 anchorages revealed a whole area where the tension in anchors fell on values well below those that would have been achieved after the excavation works.

Fig. 9 Verification stages in anchors tensions. R1 row

As shown, in the following stages, tension loss can be observed, but in only in limited areas without major consequences. Graphic representation of the residual tensions in the anchors overlapped on the anchors position on site, reveal an interesting and very precise correlation between the position of the anchors that have lost tension and the position of the faults. Thus the hypothesis of the low stability for the embedded bulbs along the transverse faults.

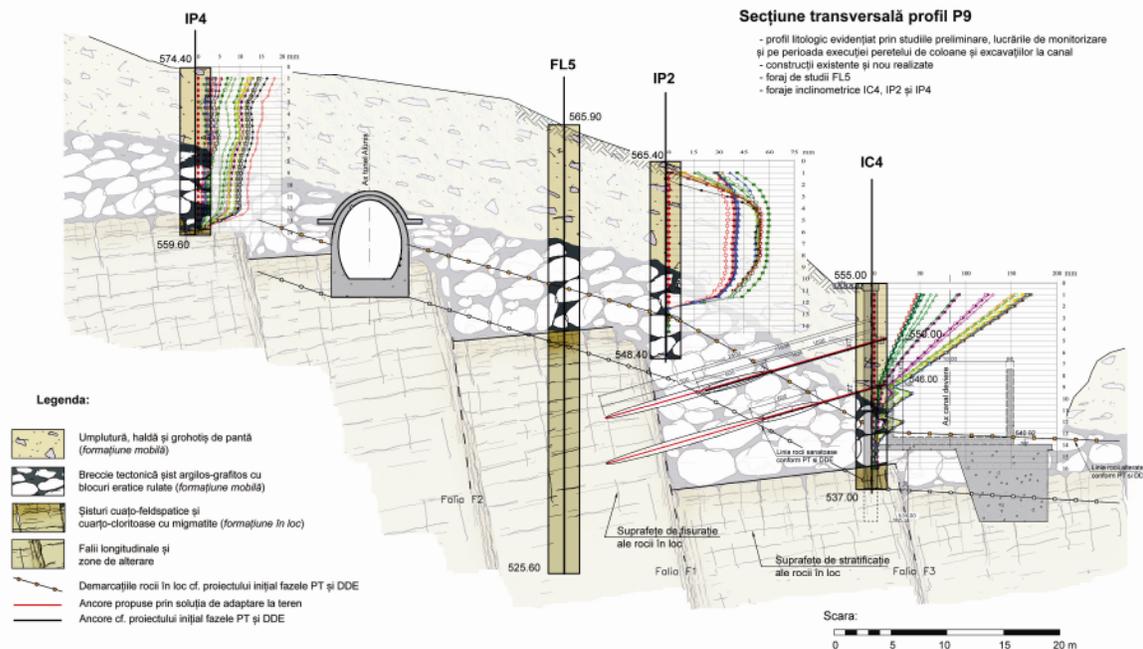
Figure 10 represents at an undistorted scale of the cross section considered representative through the axis of the dam and downstream, alongside the existing constructive elements or recently completed items (rail tunnel, columns wall, diversion channel).

Fig. 10 Representative cross section with synthesis of work studies which imposed a new image of the geological configuration and the need to modify anchoring solution.

There are also highlights on the geological details resulting from the correlation of the information from the boreholes of the old geotechnical study, old inclinometer measurements, execution descriptions of the pile columns and excavations of the diversion channel foundation. All this data led to the conclusion that there is a large discrepancy between the configuration and depth of the bedrock, depicted in the initial project, and the actual on site condition.
