Diagnostic surveys of displacements of a rotating pedestrian bridge during its movement

Ireneusz Wyczałek¹, Michał Wyczałek², Elżbieta Wyczałek²

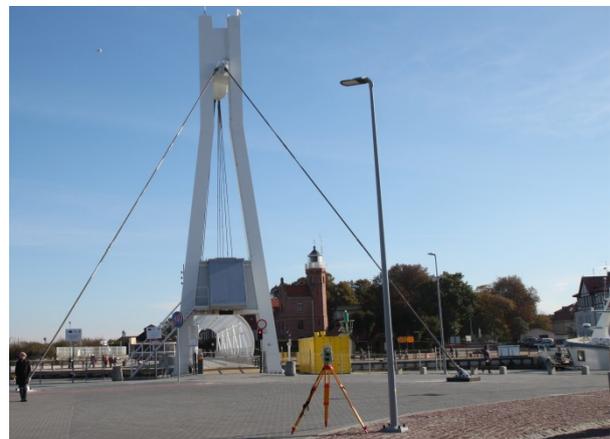
Figure 1. View of the footbridge and TS Leica TCRP 1201+ in the harbour scenery

The 50-ton footbridge is suspended to sliding bearing located on top of a 30 meter high two-legged pylon. Because the platform loads the pylon on one side, the load is balanced by two steel cables anchored in the ground on the opposite side of the pylon (Fig. 1). In the open position (Fig. 2b), the loads act on the footbridge symmetrically, while during rotation the loads are bent in one direction, which particularly affects one of the cables. While working on the construction of the port adjacent to the footbridge, the stability of the anchorages could have been disturbed, therefore the thesis on the influence of this factor as a source of undesirable vibrations was adopted.

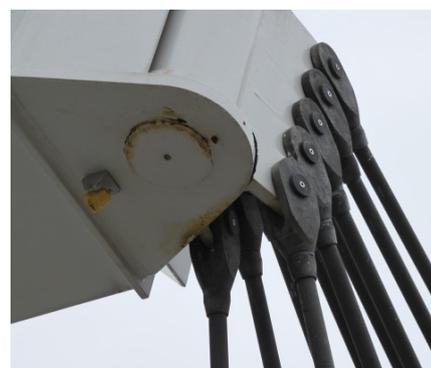
Automatic measurement from the ground station of Leica TCRP 1201+ robotic total station was made to prisms arranged on the monitored elements, as well as to the group of reference points. In order to measure dynamic phenomena, cyclical tacheometric survey was taken to a selected prism in the automatic mode with a frequency of 5 Hz and in the target tracking mode. From among the places selected for tracing, the most interesting results were provided by the point (prism) placed under the rotational suspension head of the footbridge (Fig. 3).

Figure 3. Leica GPR112 prism in the lower part of the rotating head holding the footbridge with the help of cables.

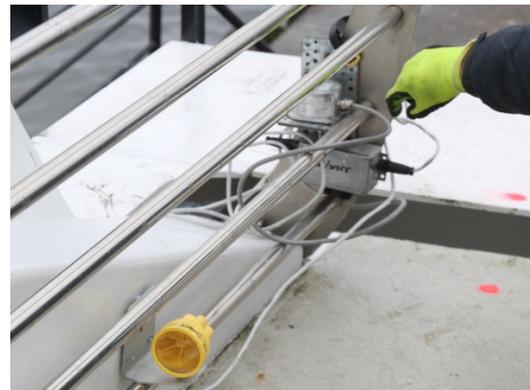
of the prisms (as shown in Figure 5), including loss of visibility due to obstructions by some elements of the structure. An important factor was also capturing the moment of start and course of vibrations of the footbridge, which were noted earlier for turning it of $5-10^\circ$ from the open position.

In order to evaluate changes in the slope of the footbridge, two two-axial inclinometers Posital Canopen AGS15 were installed on it. Inclination measurements were recorded continuously for several days (Figure 5).

Figure 5. Inclinometer Posital AGS15 with counting device and the prism mounted at the end of the footbridge.
