Czech Technical University in Prague
Faculty of Civil Engineering

Terrestrial Laser Scanning for the Fire Test on Experimental Building in Mokrsko

Tomáš Křemen, Václav Smítka and Jiří Pospíšil

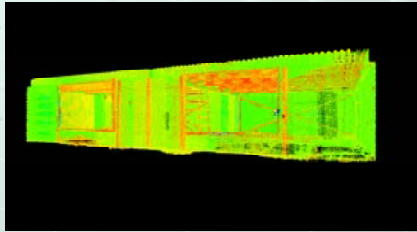
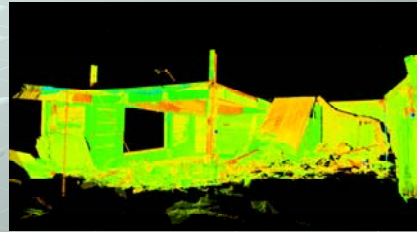
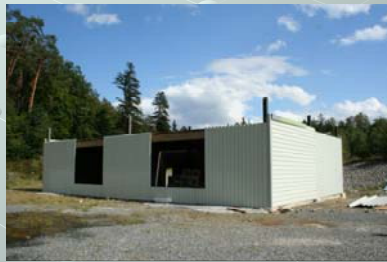
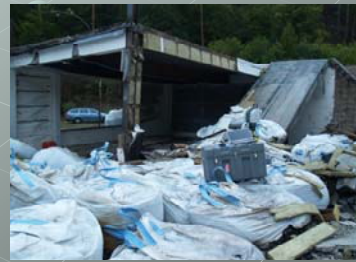
Final point clouds before and after fire test

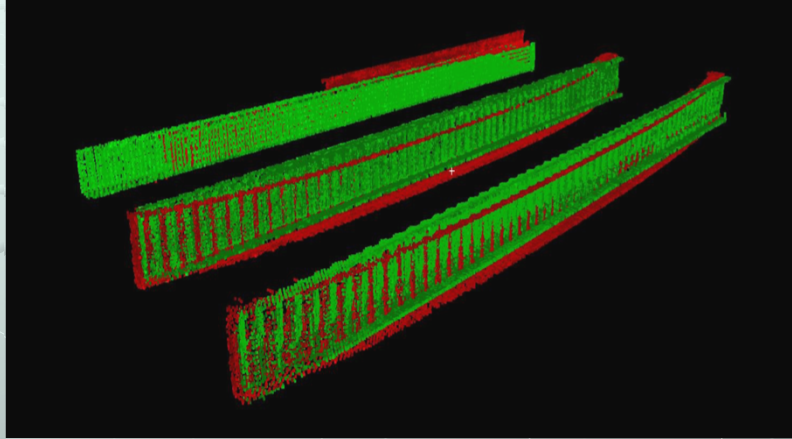
Evaluation of beams

- Collapse of the building during the fire test
- Evaluation not collapsed elements of construction:
 - Three ceiling beams
 - Central column
 - Wall constructions
 - Monolithic concrete wall
 - Kingspan sandwich panels

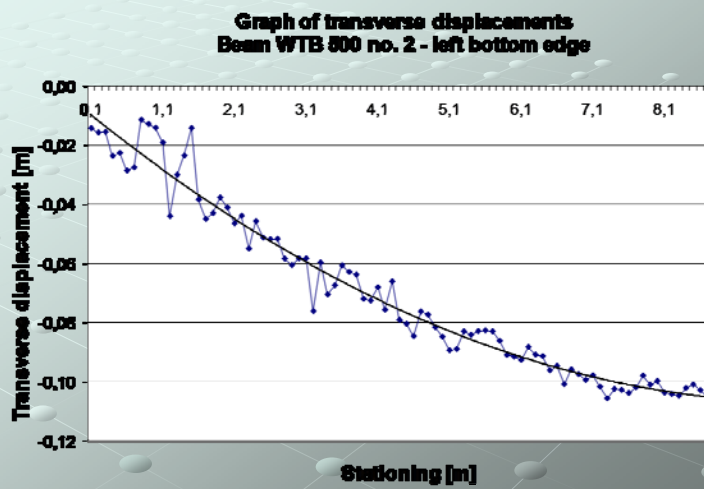
Evaluation of beams - graph

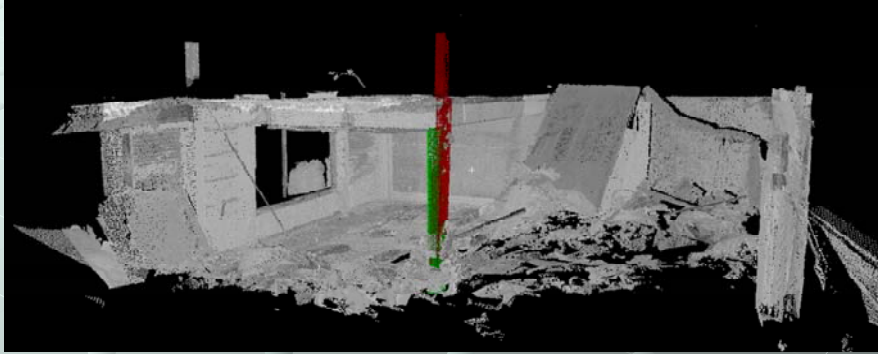
Evaluation of central column

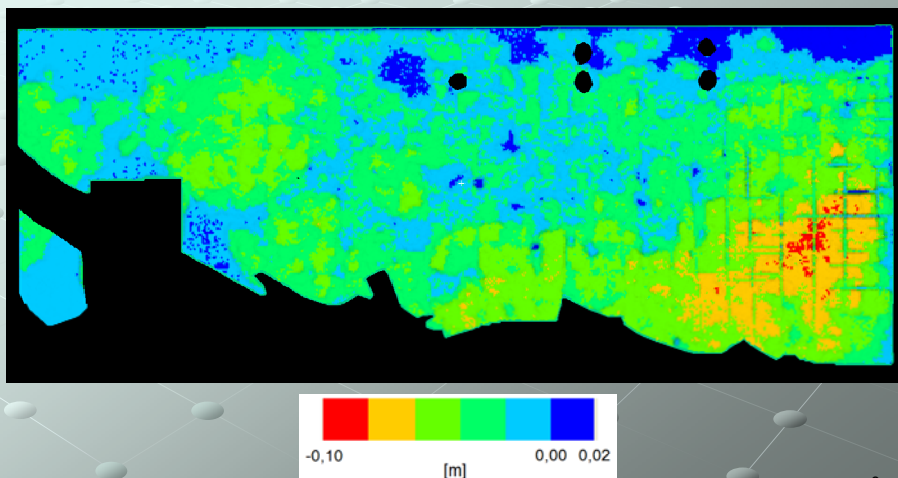
Evaluation of concrete wall – difference model

- Evaluation of static deformation of the experimental building after the fire test
- Difference models of walls with hypsometric expression of deformation provide unique information about behavior of the building construction
