Use of Cadastral Data in Recovery from Disaster - Quality Issues

Leiv Bjarte MJØS, Norway

FIG Working Week 2016
Recovery from Disaster
Christchurch, New Zealand, May 2–6, 2016

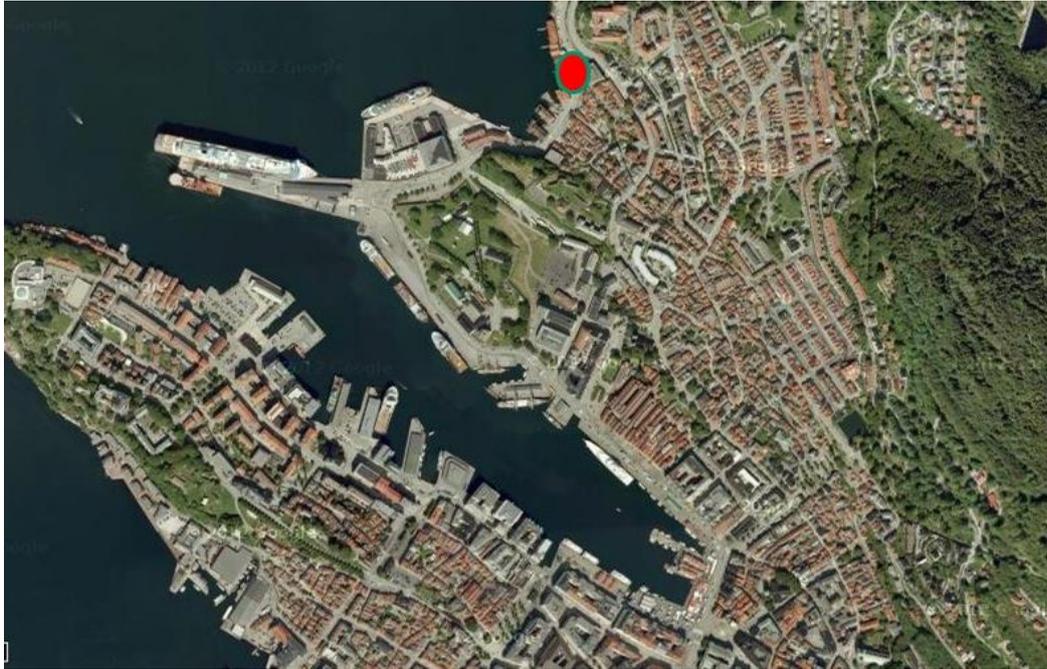
Figure 3. Map with fire place marked with red spot. Source: Statens kartverk

In September 2008 four properties in Skuteviken area in Bergen, the second largest city in Norway, were hit by fire. Skuteviken is an area near by the city center, with high property values.

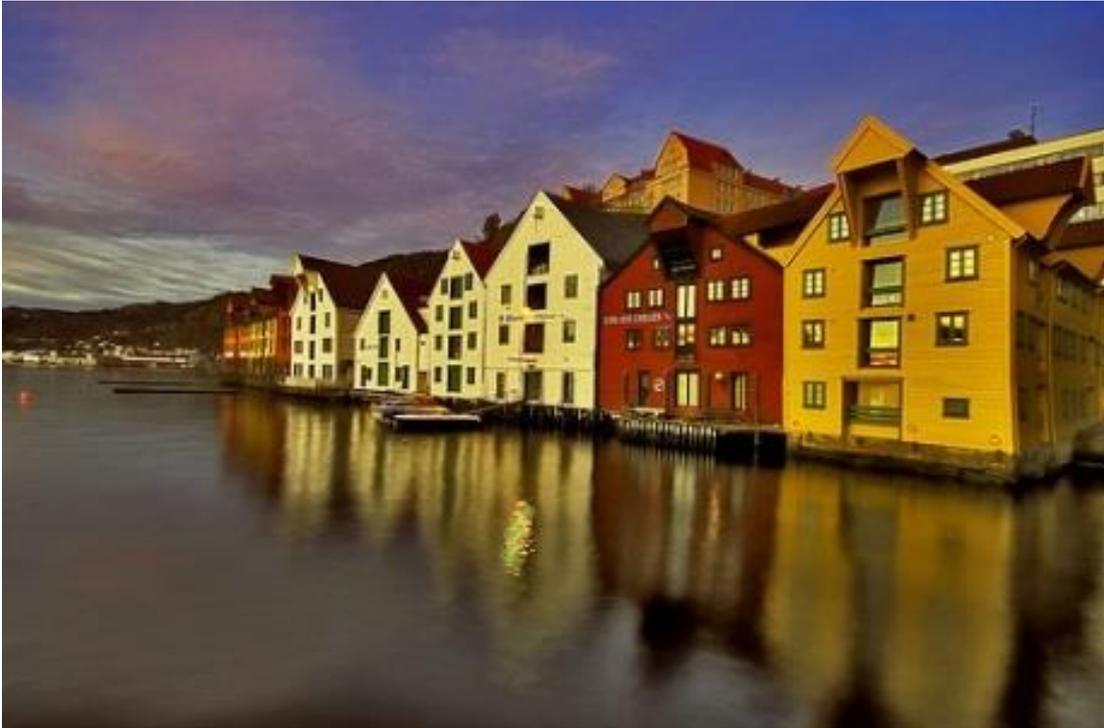
Figure 4. Before the fire. Source: unknown

The four properties involved were Skuteviksbodene no. 11 (167/879), Skuteviksbodene no. 12 (167/880), Skuteviksbodene no. 13 (167/881) and Skuteviksbodene no. 14 (167/882). The buildings no. 11 and no.14 were only partly damaged and were repaired, while no. 12 and 13 were totally damaged.

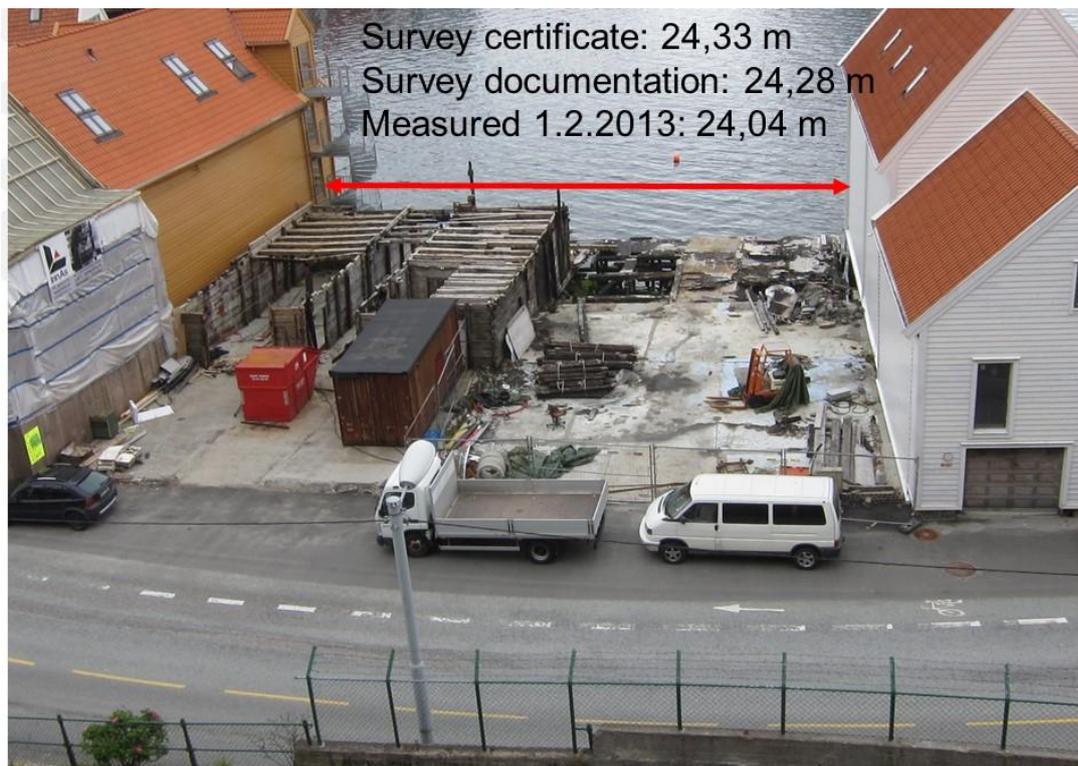
Figure 10. How can the deviations be explained, and how handle it? Photo: Leiv Bjarte Mjøs

The next question is shown in Figure 10. The survey certificate showed a distance between no. 11 and no. 14 of 24.33 meters, the corresponding original survey documentation showed

24.26 meters, and tape measure showed that the actual distance between the houses were 24.04. There were discussions and many arguments about what had caused this, on centimeter level.

My view on the most relevant theory was that when the houses at no. 11 and no. 14 were repaired, they were expanded each with 15 cm because of isolation of the house outer wall. My proposal was to compare photographs from before the fire in 2008, with photographs after the houses had been rebuilt, to find an answer to the question.

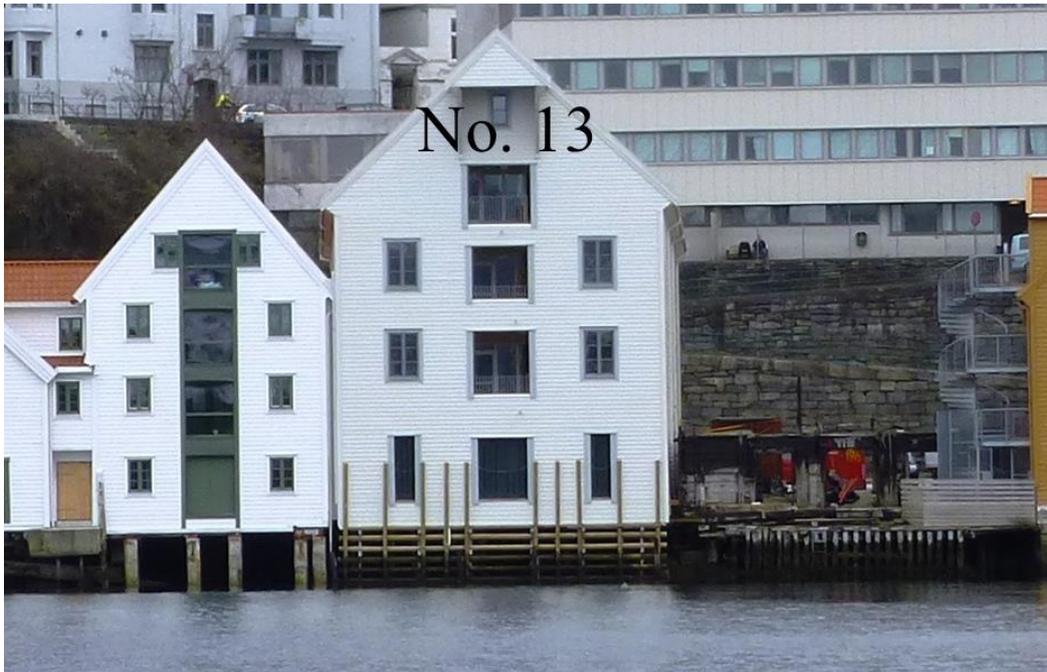
Figure 11. Skuteviksboder no. 13 after reconstruction in 2014. No. Photo: Leiv Bjarte Mjøs

Anyhow, the owner of no. 13 reduced the width of his house towards the sea, with 7 cm, and the owners of no. 12, 13 and 14 agreed about the exact position of the new house on no. 13. The problem was then resolved, and the reconstruction of Skuteviksboder no. 13 could start. Within one year the property was reconstructed, see Figure 11. An alternative to the agreement between the parties, was the court system.
