Presented at the FIG Congress 2022,
11-15 September 2022 in Warsaw, Poland

Automated Inspection within Galleries of Large Dams

Structural Health Monitoring and Inspection

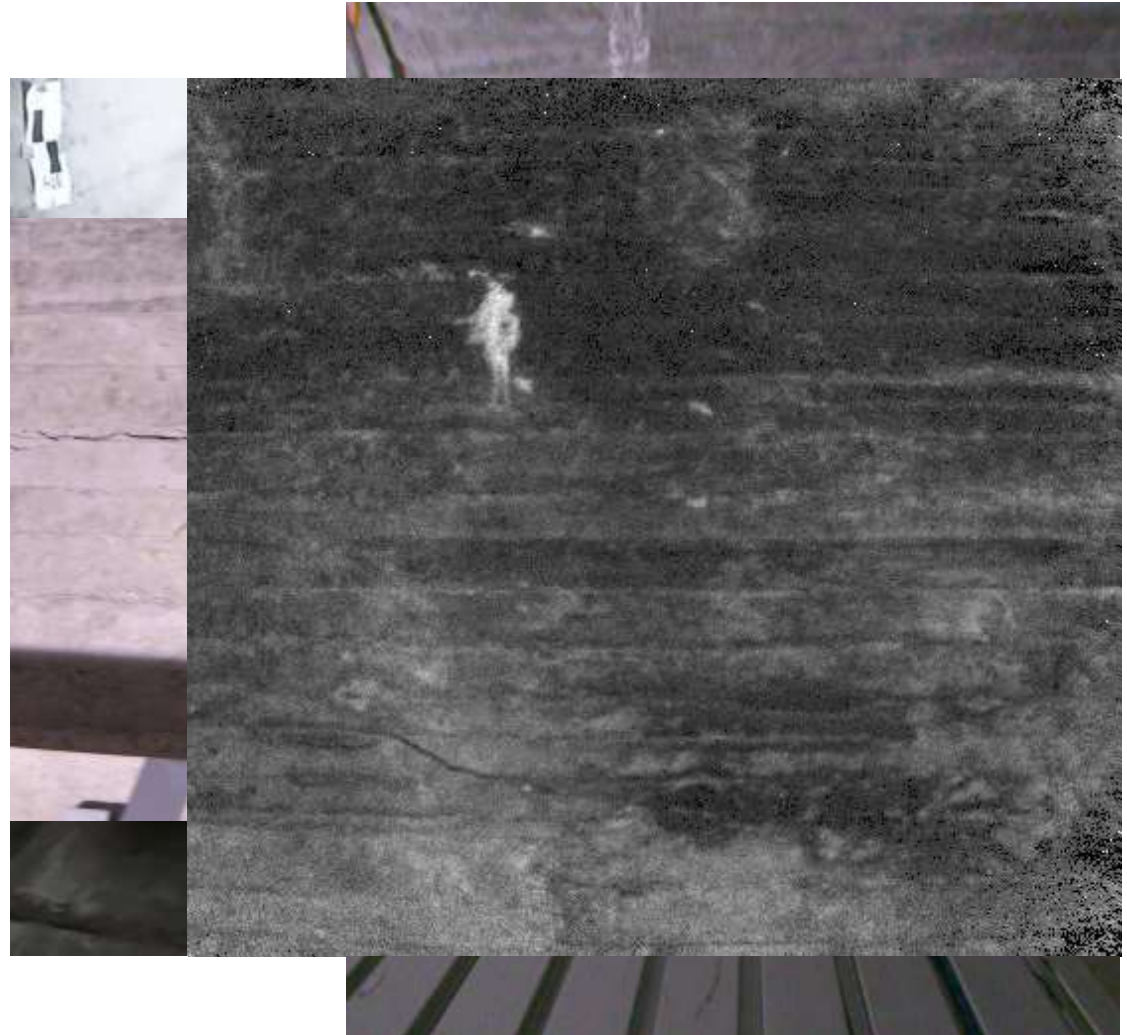
Sensors

1. DSLM camera *Lumix DMC-FZ2000*
Pixel size at 1 m : 0.3 mm/px

2. Mapping system *Leica BLK2Go*
Pixel size at 1 m : 1.6 mm/px

3. Depth camera *Helios Time of Flight 3D Camera*
Pixel size at 1 m : 1.7 mm/px

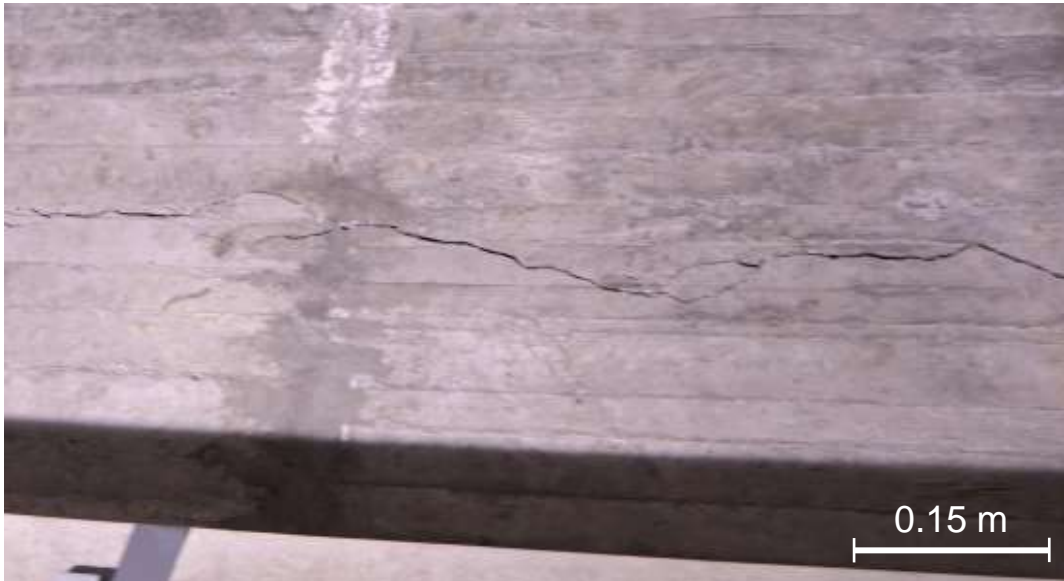
DSLIM

Results

DSL	BLK2GO	Depth Camera
Image Localization	needs photogrammetric model, trajectory	trajectory with drift	needs photogrammetric model, trajectory
False-Negative (crack not detected)	~ 30 %	~ 60 %	-
Minimal Detectable Crack Width	> 1 mm	> 2 mm	> 6 mm (no thinner cracks on analyzed pictures)

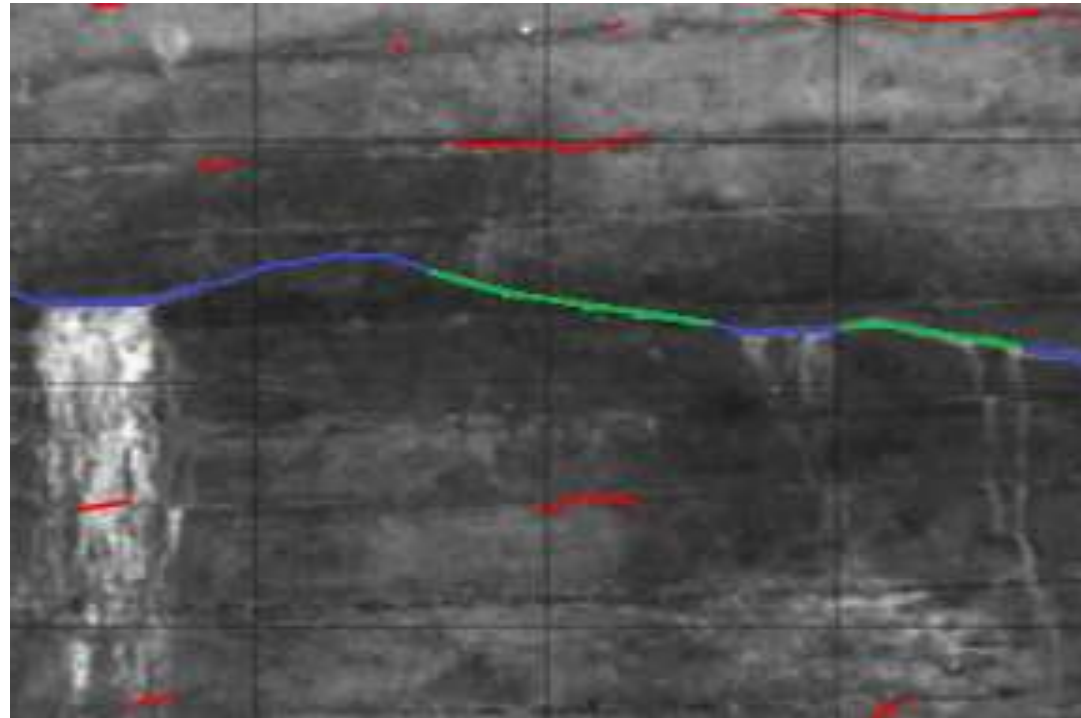
Figure 9: Cracks on the intensity image of the depth camera (green: correct detected, blue: false-negative values, red: false-positive values)
